Hatherwood Battery Isle of Wight

NGR 430717 85796
CITiZAN region: South West

Report on a CITiZAN site survey

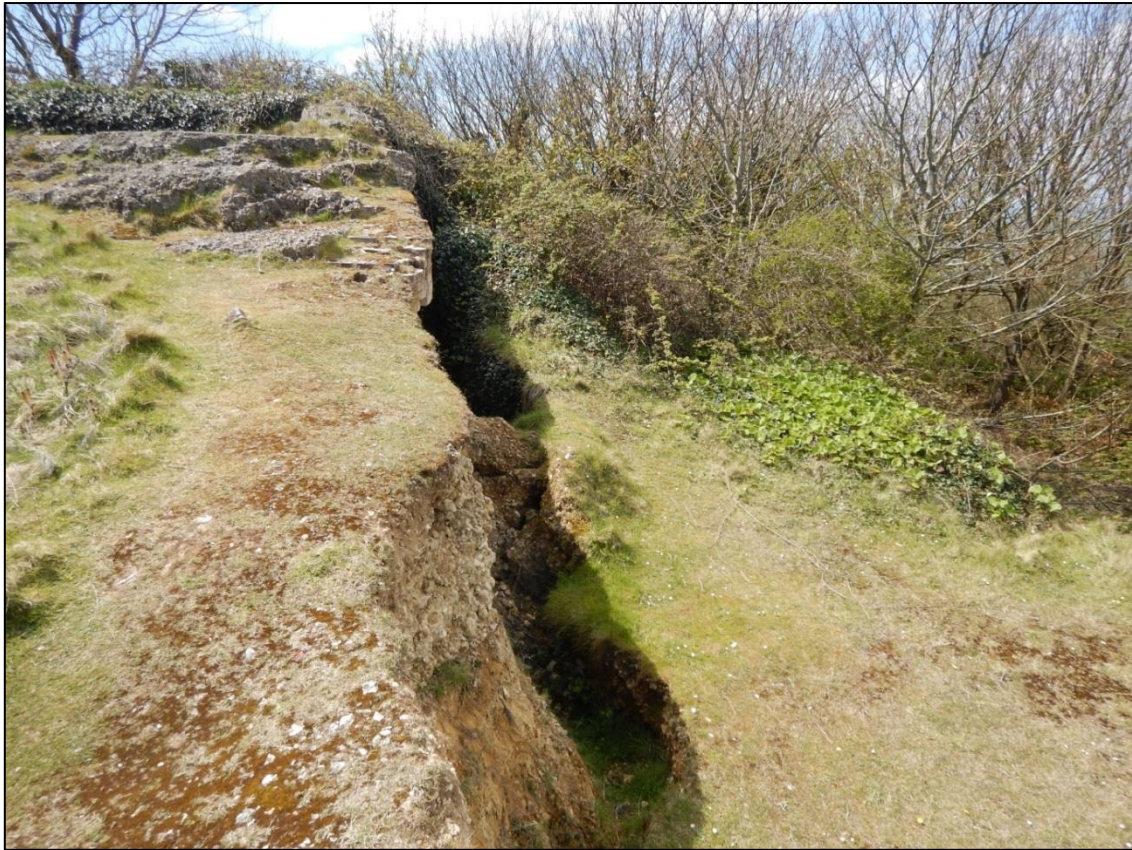
Figure 14: Looking west/south west along area of slumpage affecting A Group, the concrete structure on the top of the 'cliff' at the rear of the image is the remains of Gun 1 of B Group.

The condition of Hatherwood Battery overall is Poor (as defined by the Historic England guidance). There is clear and demonstrable evidence of cliff collapse and slumping. This has caused structural instability resulting in the loss of A Group. On inspection one of the emplacements of A Group was identified within a landslip deposit and the other was identified in woodland further down the cliff. There are no upstanding structural remains of this group or the magazine (as per the 1891 plan) but remains of the foundations were visible within the cliff section. This was drawn at a 1:20 scale and photographed during the assessment in November 2015 (Figures 14 - 20).

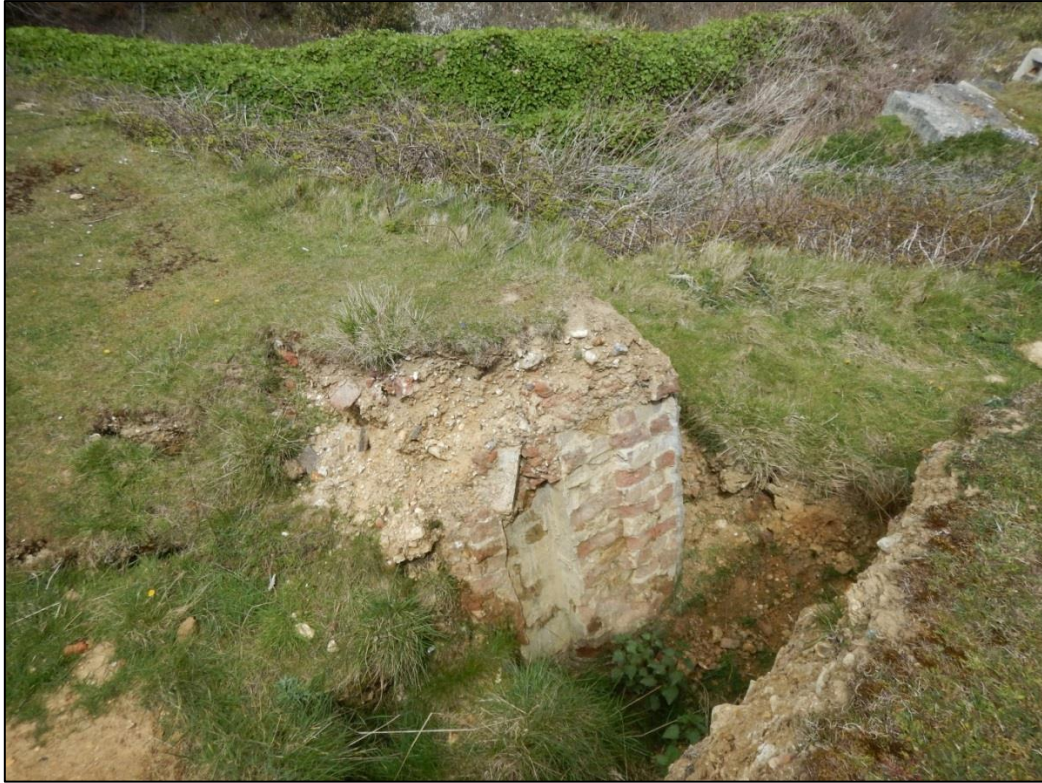
Figure 15: Looking north over some masonry remains of A Group which has slumped down, in the top right of the picture remains of Gun 2 of A Group are visible.

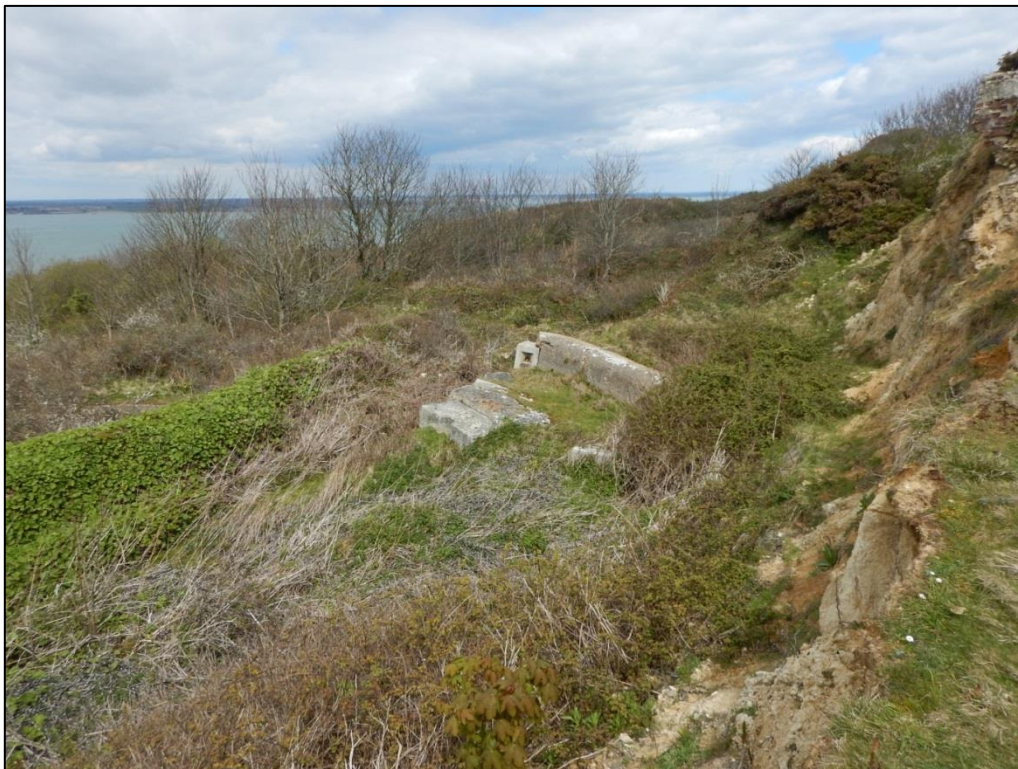
Figure 16: Looking north/north-east over the concrete remains of Gun 2 of A Group.

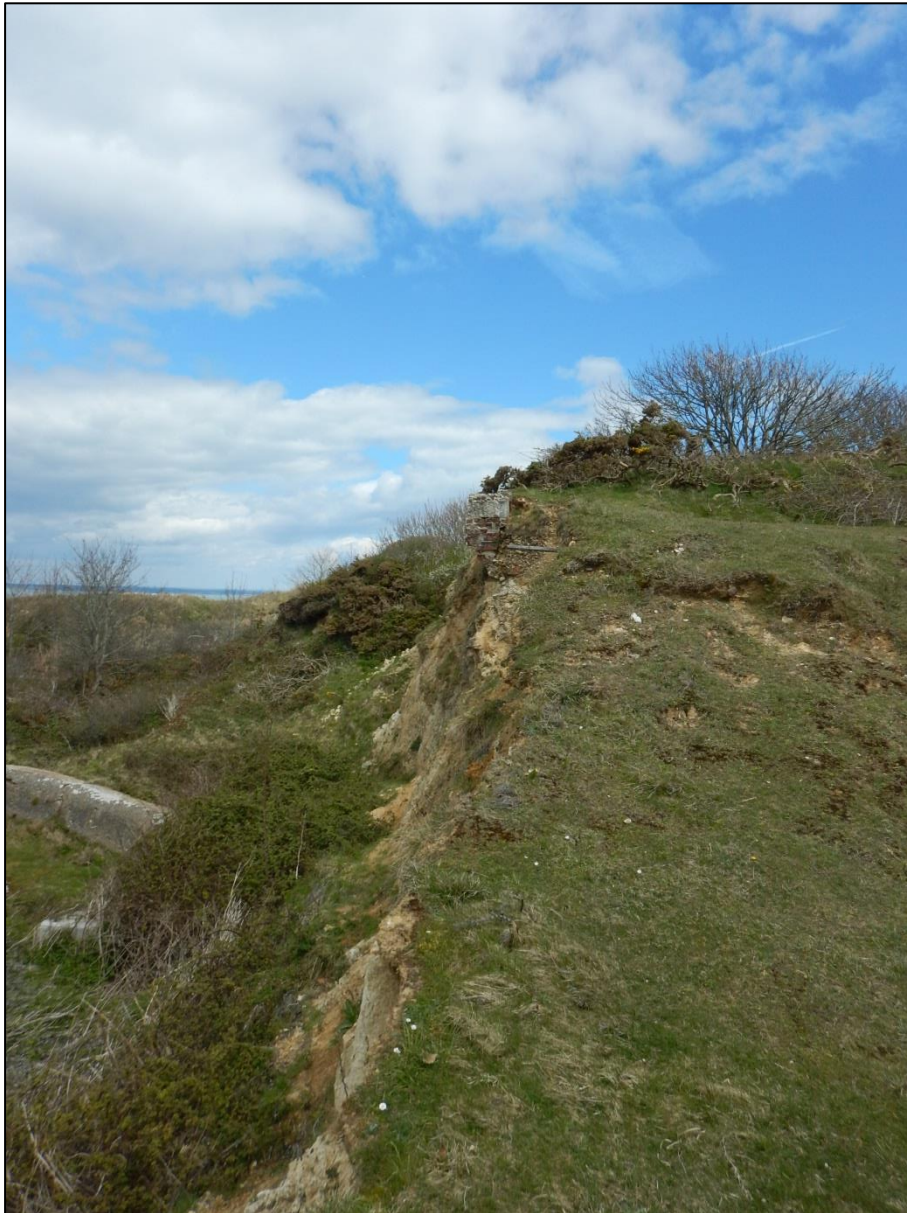
Figure 17: Looking east, remains of Gun 2 of A Group in the foreground and further masonry and pipe work eroding out of the cliff in the background.

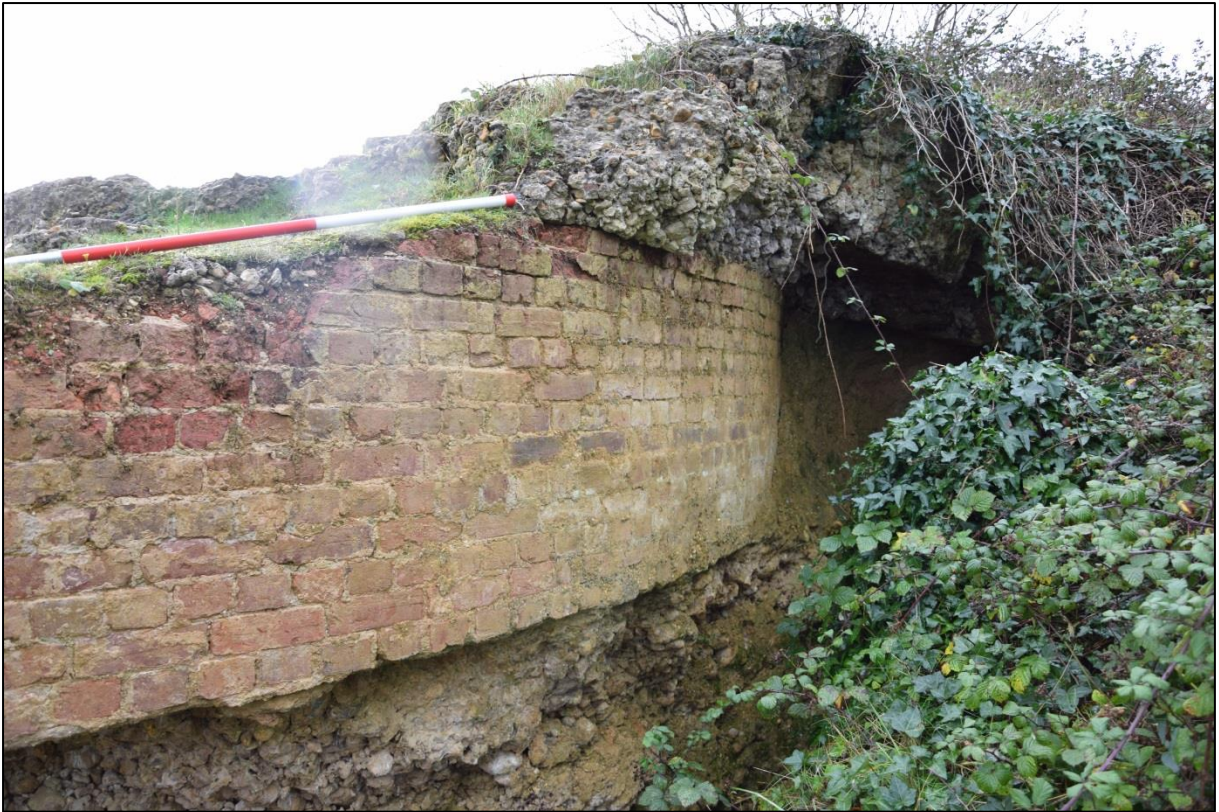
Figure 19: Masonry structures eroding out of cliff, camera facing south-east.

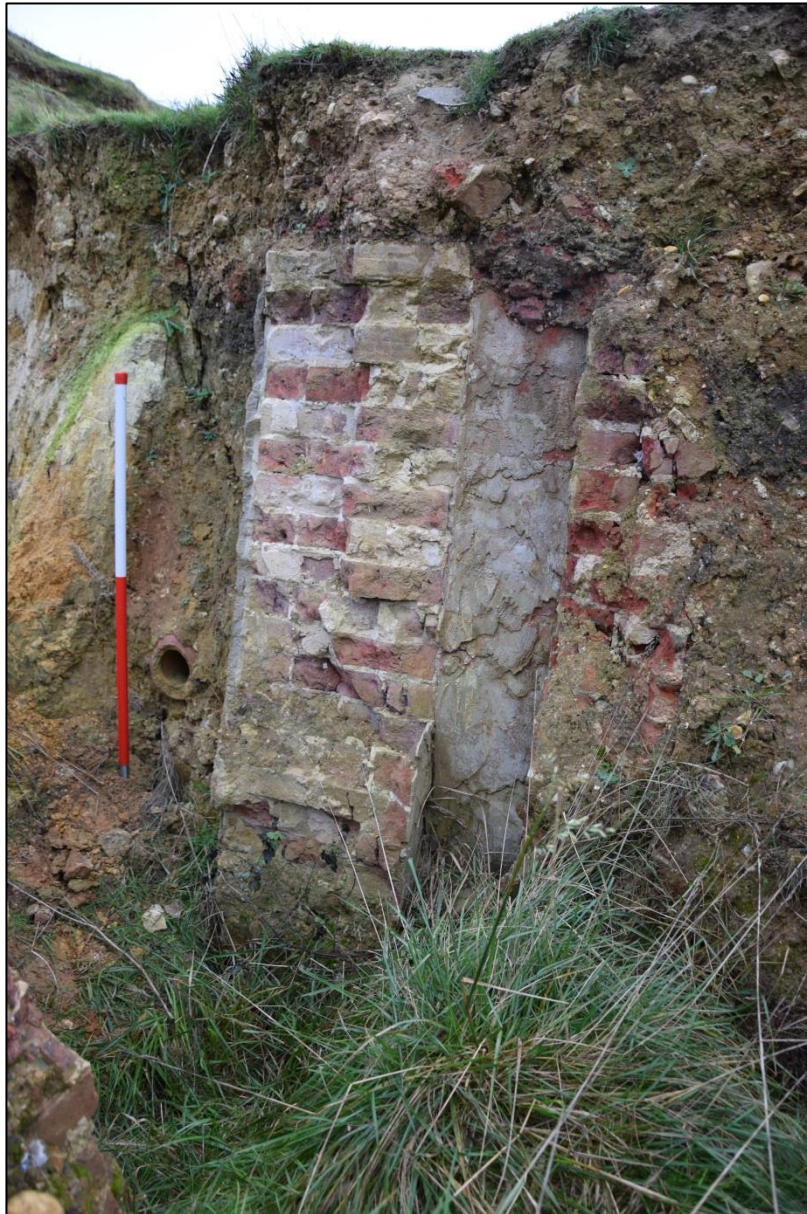
Figure 20: Masonry and pipework eroding out of the cliff. Camera facing south-east.

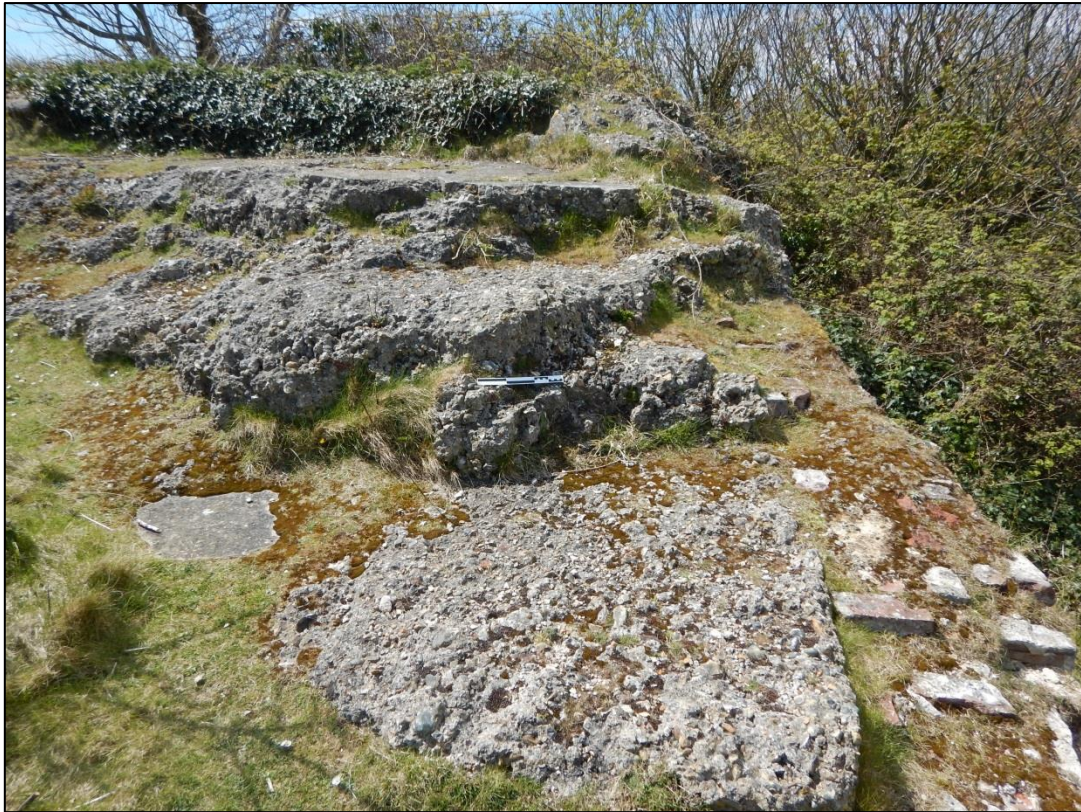
Figure 21: Looking northwest of remains of Gun 1 B Group.

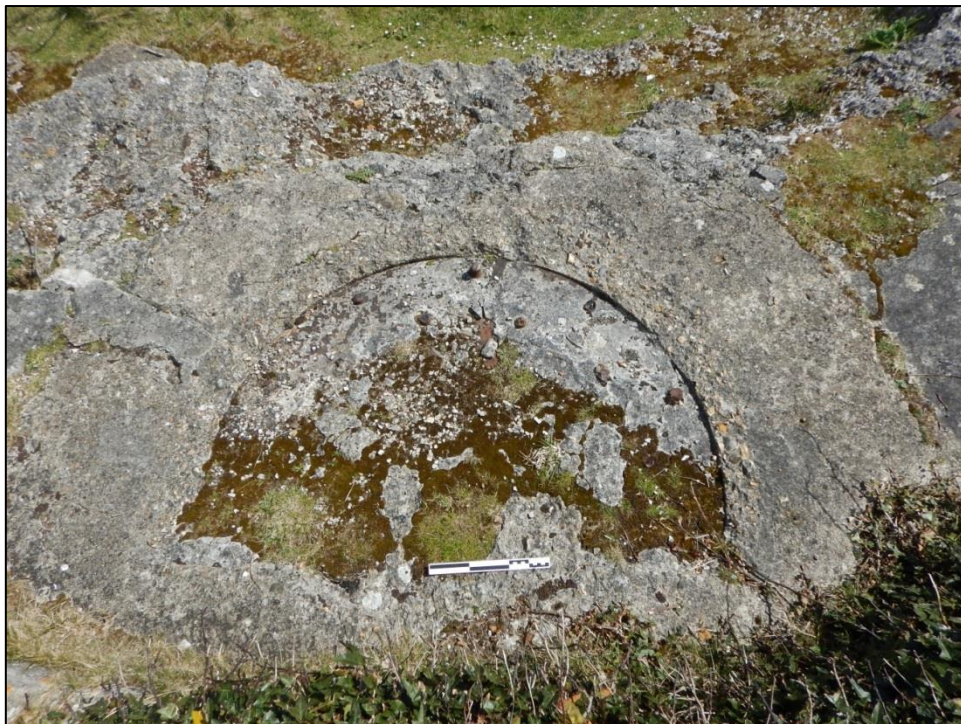
Figure 24 illustrating the fittings of where Gun 1 of B Group would have been held in place.

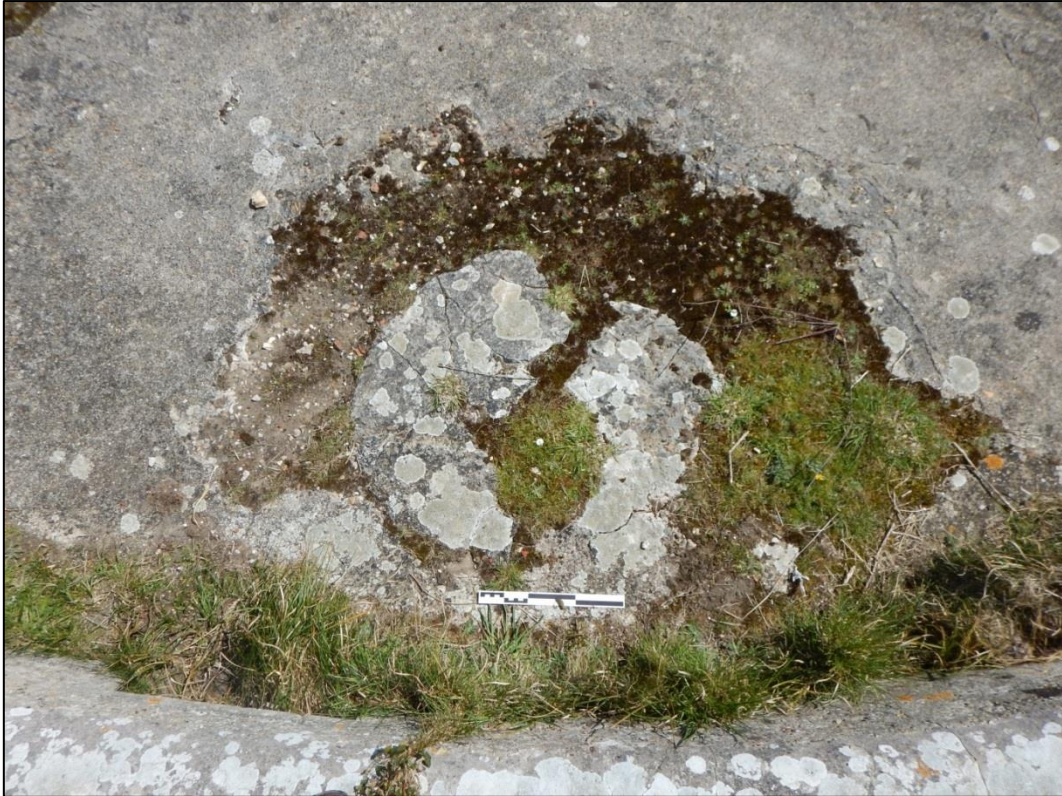
Figure 31: Fitting for Gun 2 in Group B.

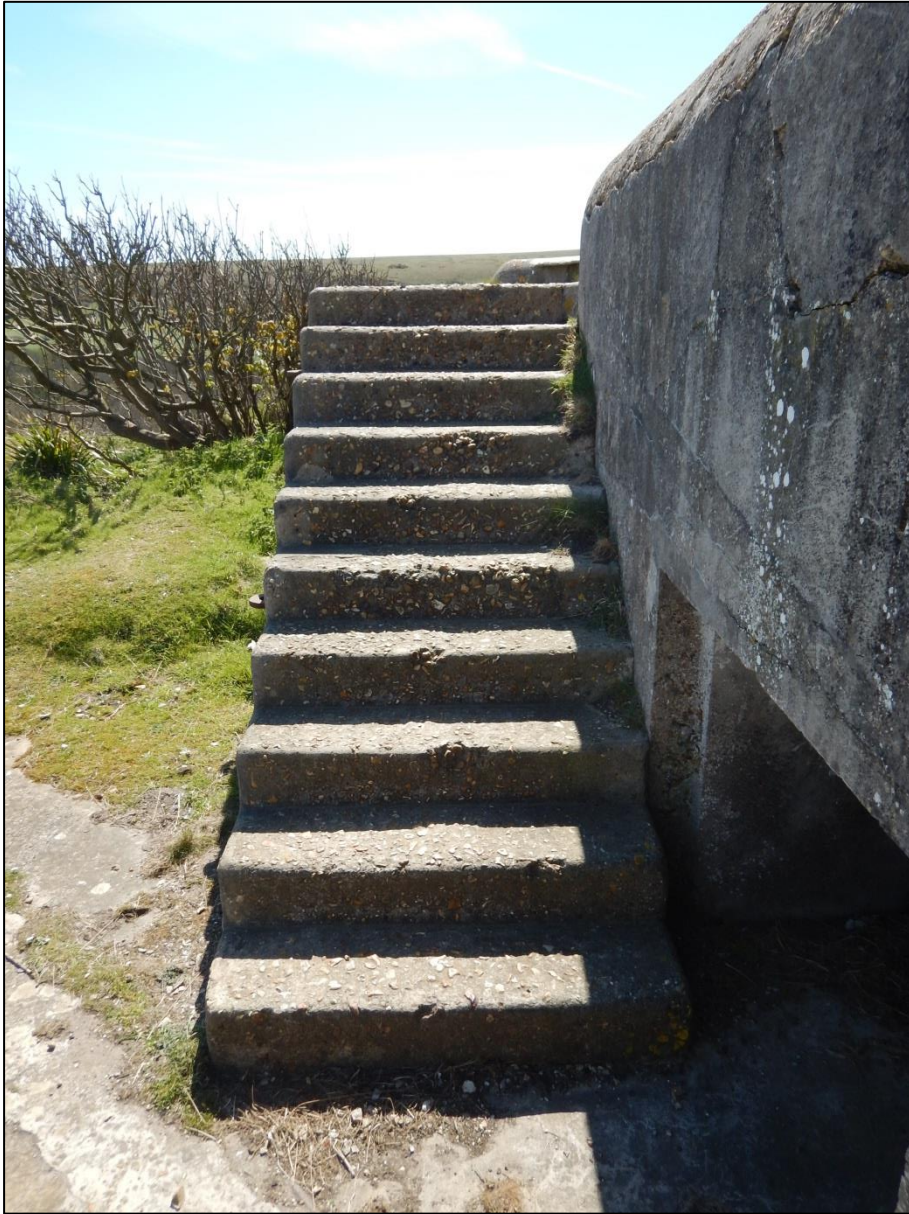
Figure 35: Looking south over west stairs in C Group.

The gun positions are accessed via stairs on each emplacement, whilst the stairs to the eastern emplacement are damaged those on the west are of good condition. Three stores are visible in the south-eastern elevation of the battery and there are metal fixings sunk into the concrete around this area. The north-western elevation was not observed due to inaccessibility.

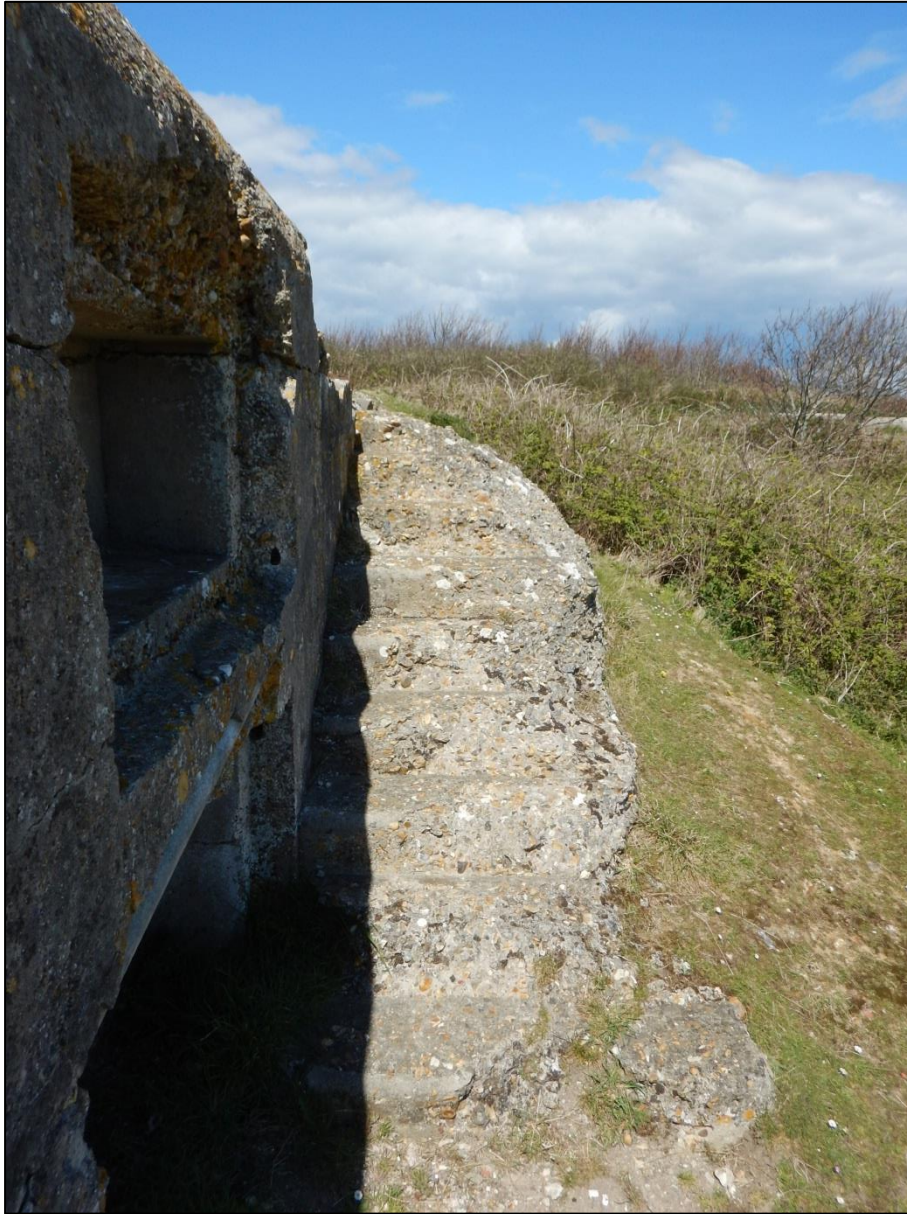
Figure 36: Looking north over east stairs. Note the difference in deterioration of the west and east stairs in C Group.

The condition of C Group is fair, with this group being the best preserved. The eastern section is suffering from a moderate amount of vegetation encroachment which is leading to root damage of the monument. This is particularly apparent in the stairs to the east emplacement which are in a

very poor condition. The western emplacement has a large crack running across concrete which can be seen in section. However, these are the only visible structural deformities of the Group.

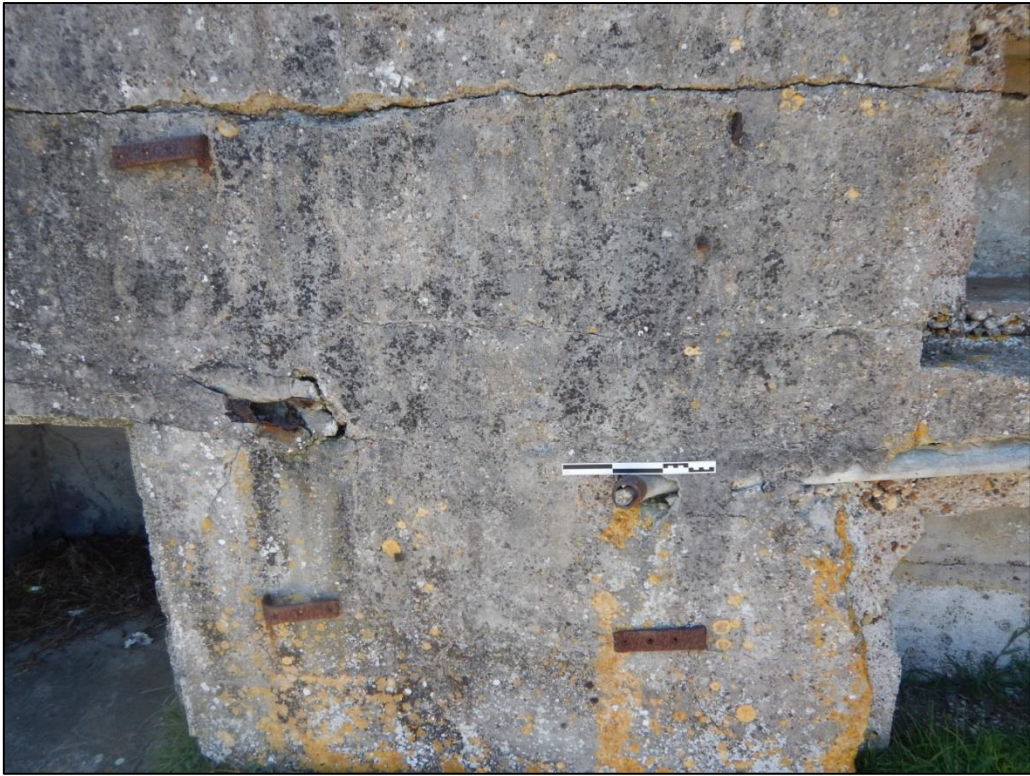
Figure 39: Looking west, pipework under C Group.

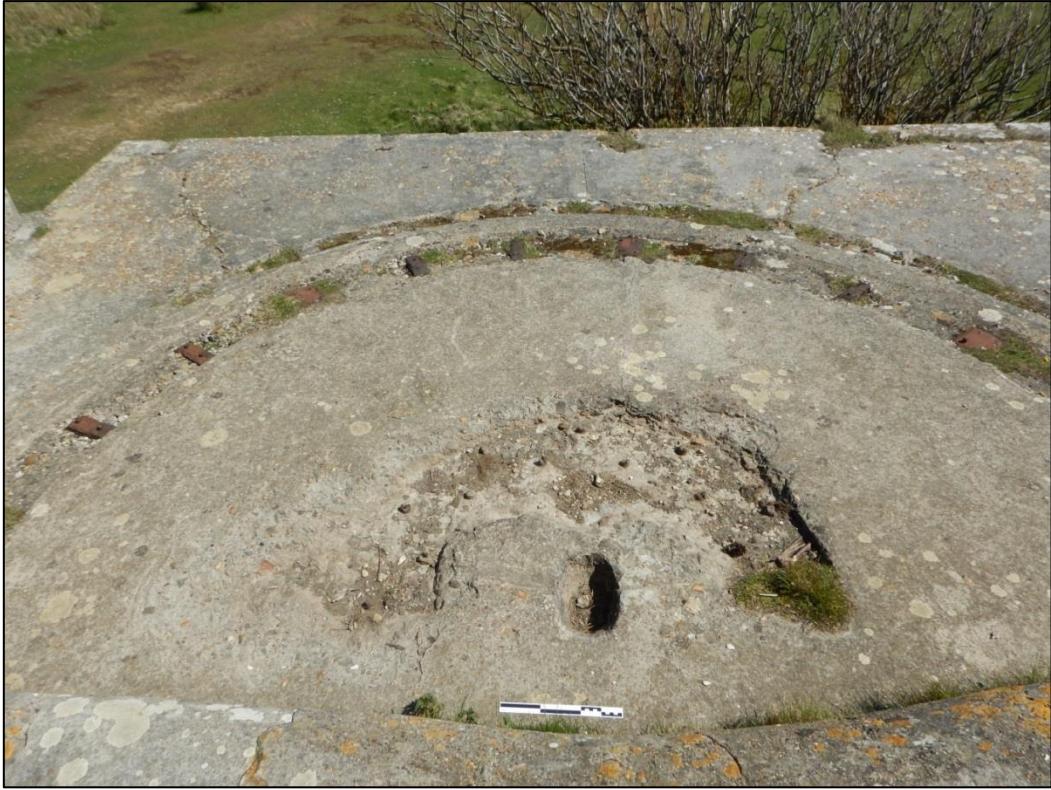
Figure 43: Looking east/north-east over the base which would have been gun 2 of C Group.

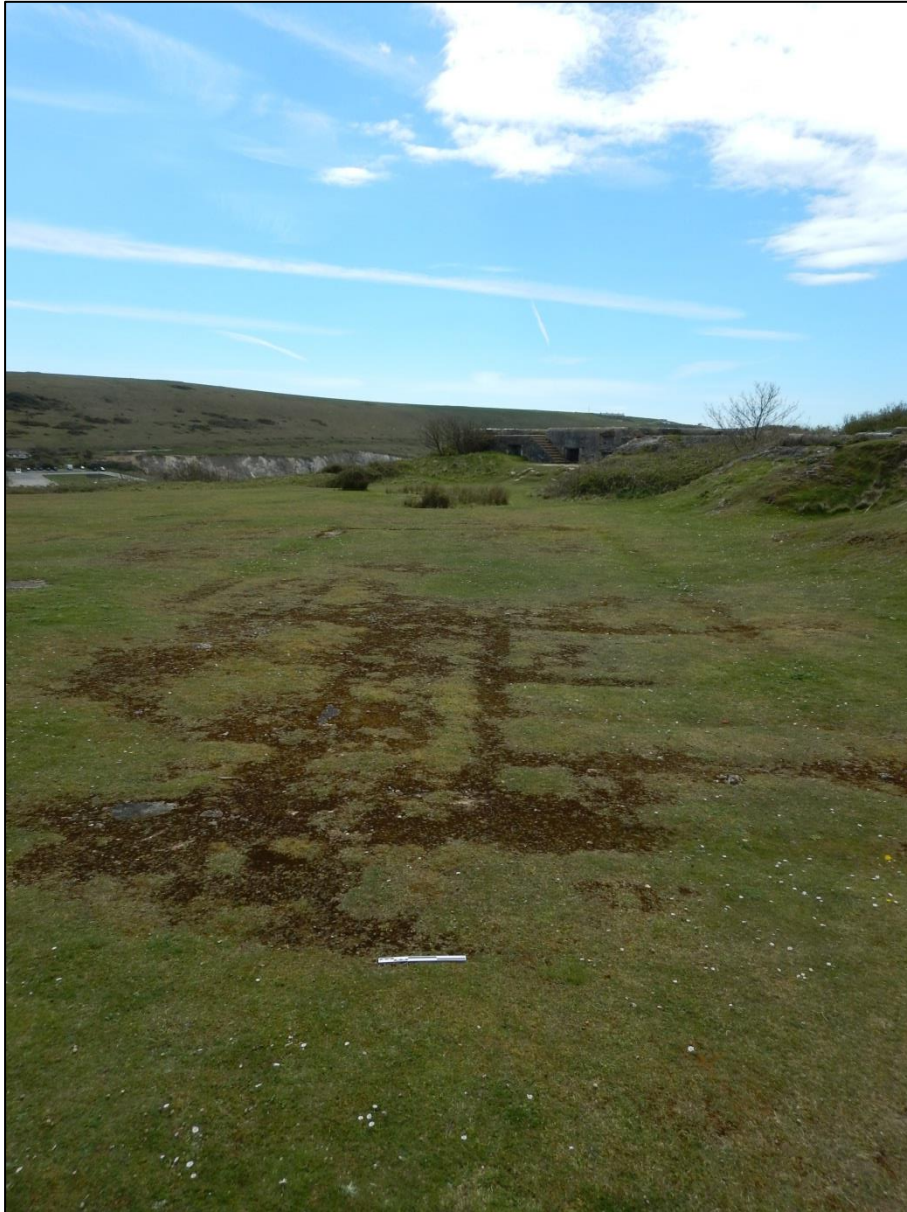
Figure 47: Looking south-west towards C Group illustrating the foundations visible from the buildings at the indicator loop station.
